GOVERNMENT OF NEPAL
AIRCRAFT ACCIDENT INVESTIGATION COMMISSION

PRELIMINARY REPORT ON ACCIDENT INVESTIGATION

9N-AME (CRJ 200LR, MSN 7772) Aircraft

Saurya Airlines Pvt. Ltd.

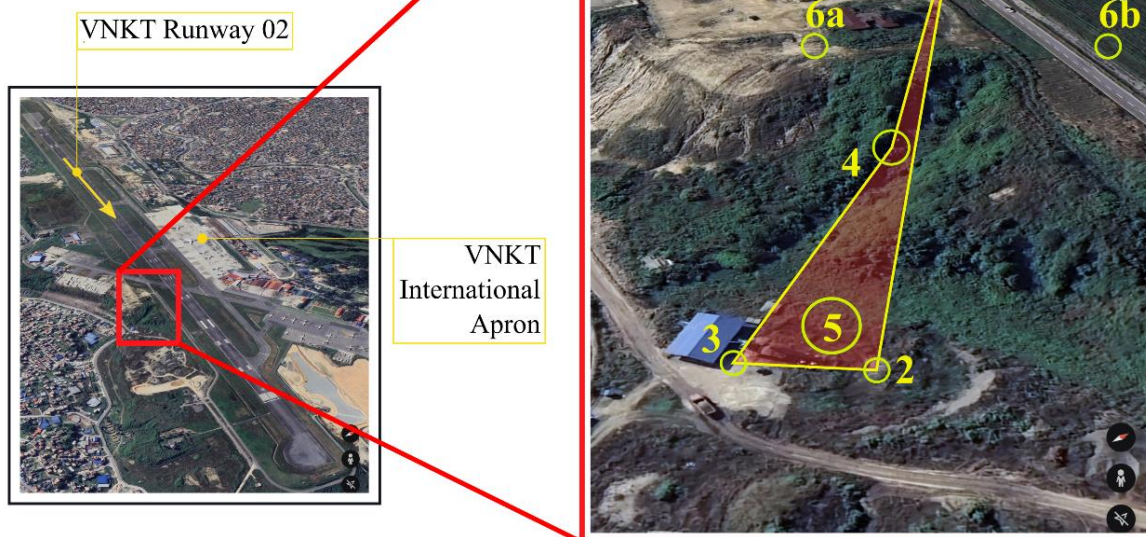
Figure 1: Site corners showing the initial impact and components distribution

- 1- First impact by right wing
- 2- Left engine (detached w/ pylon) & cowl
- 3- Ejected seat & right engine nacelle
- 4- Cockpit (detached aft of cockpit door frame)
- 5- Fuselage & left-wing wreckage

- 6a- Emergency door
- 6b- Detached winglet

The markers on the site of the accident are shown in Figure 1. The right wing first impacted on the ground at '1' (05:26:10 UTC), marking the start of the disintegration of the right wing and the subsequent accident.

- The fuselage of the aircraft lay in two distinct parts, at '4' (cockpit) and '5'.
- The left wing and the right engine were attached to the fuselage at '5'.
- The left engine was found detached at '2'.

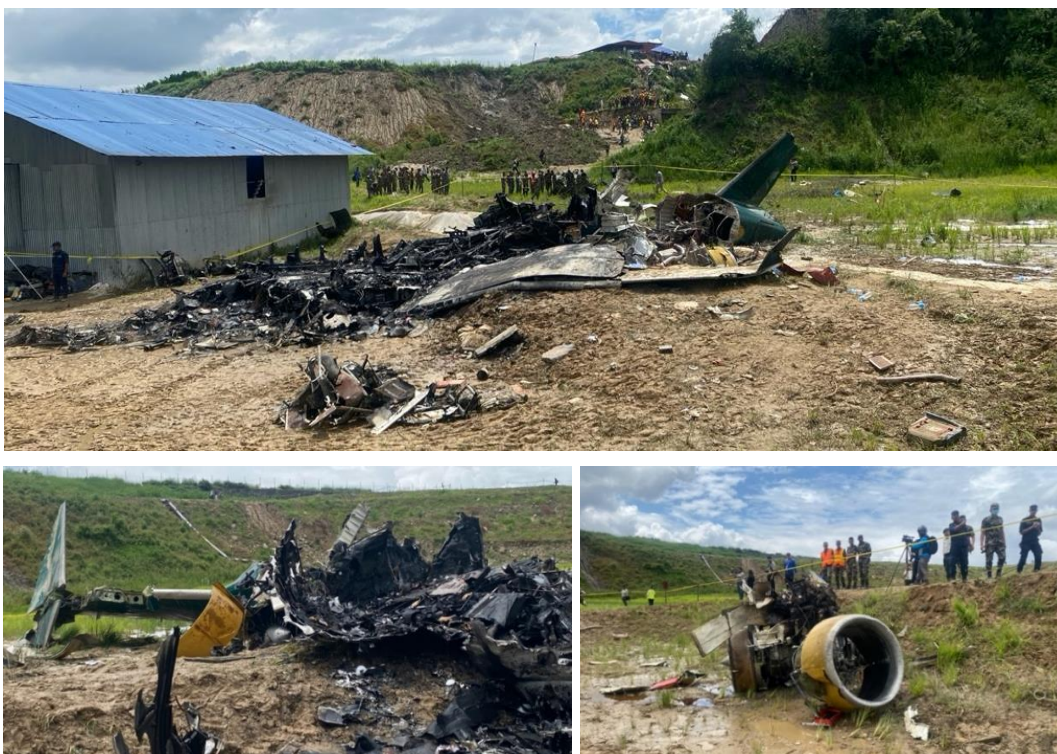
Figure 2: Top: scene at '5', with '4' just above on the hill, bottom: burnt fuselage and empennage sections at '5' and left engine at '2'

The aircraft was destroyed due to high velocity impact, and post impact fire as seen in Figure 2.

The aircraft also collided with the container and shed of Air Dynasty Heli Services Pvt. Ltd. The cockpit portion was stuck on the container and shed which was found at '4', on the eastern side of the airport. Most of the fuselage structure and its components were damaged due to fire

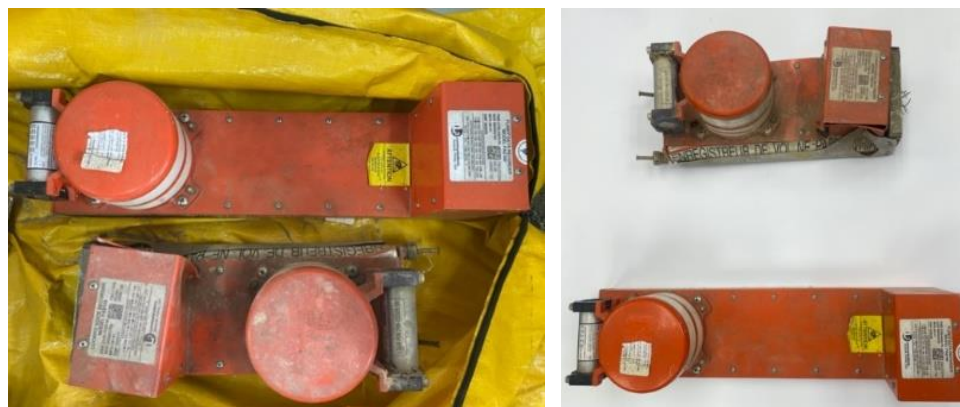
Figure 3: Condition of recorders as received by AAIC (left), and after being transported to TSIB, Singapore (right)

The details of both recorders are presented in Table 3. In addition, Figure 3 depicts the condition of recorders.

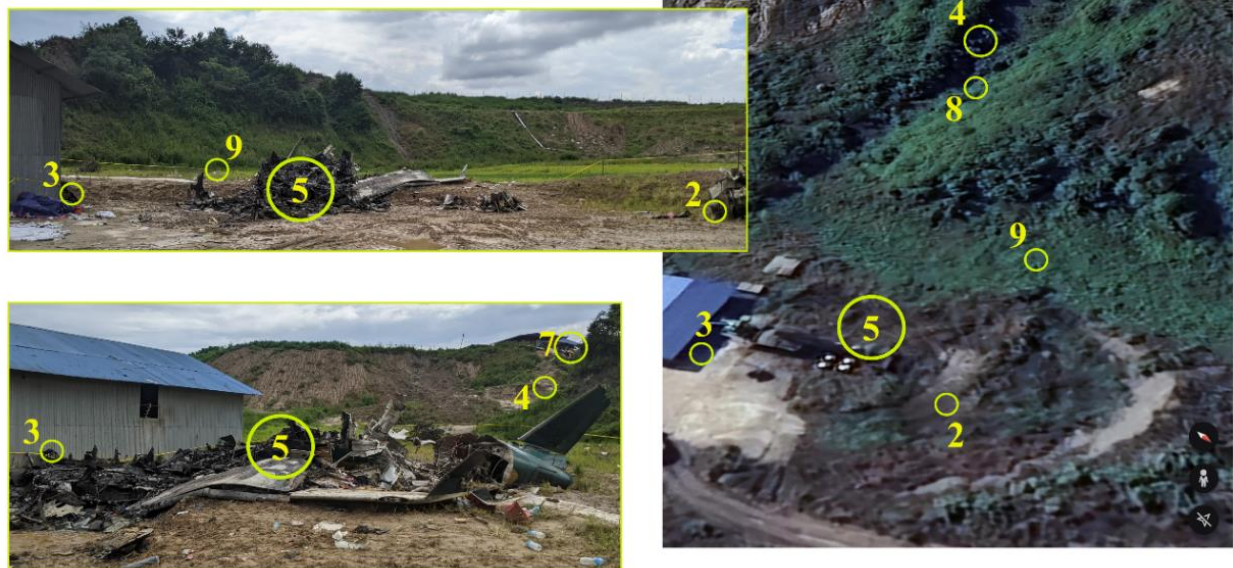
Figure 4: Overall distribution of the wreckage (see Figure 1 for markers '1' to '5')

The collision of 9N-AME with the container and shed of the Air Dynasty Heli Services Pvt. Ltd. led to damage of Air Dynasty properties. Mainly, the container of Air Dynasty was dragged from '7' to '4' (see Figure 1 and Figure 4). It was partly destroyed during the impact and further taken apart

- 7- Air Dynasty container/shed site
- 8- Air Dynasty (mixed) wreckage
- 9- Fuel drum dragged/ejected from 7
- 10- Radome & weather radar

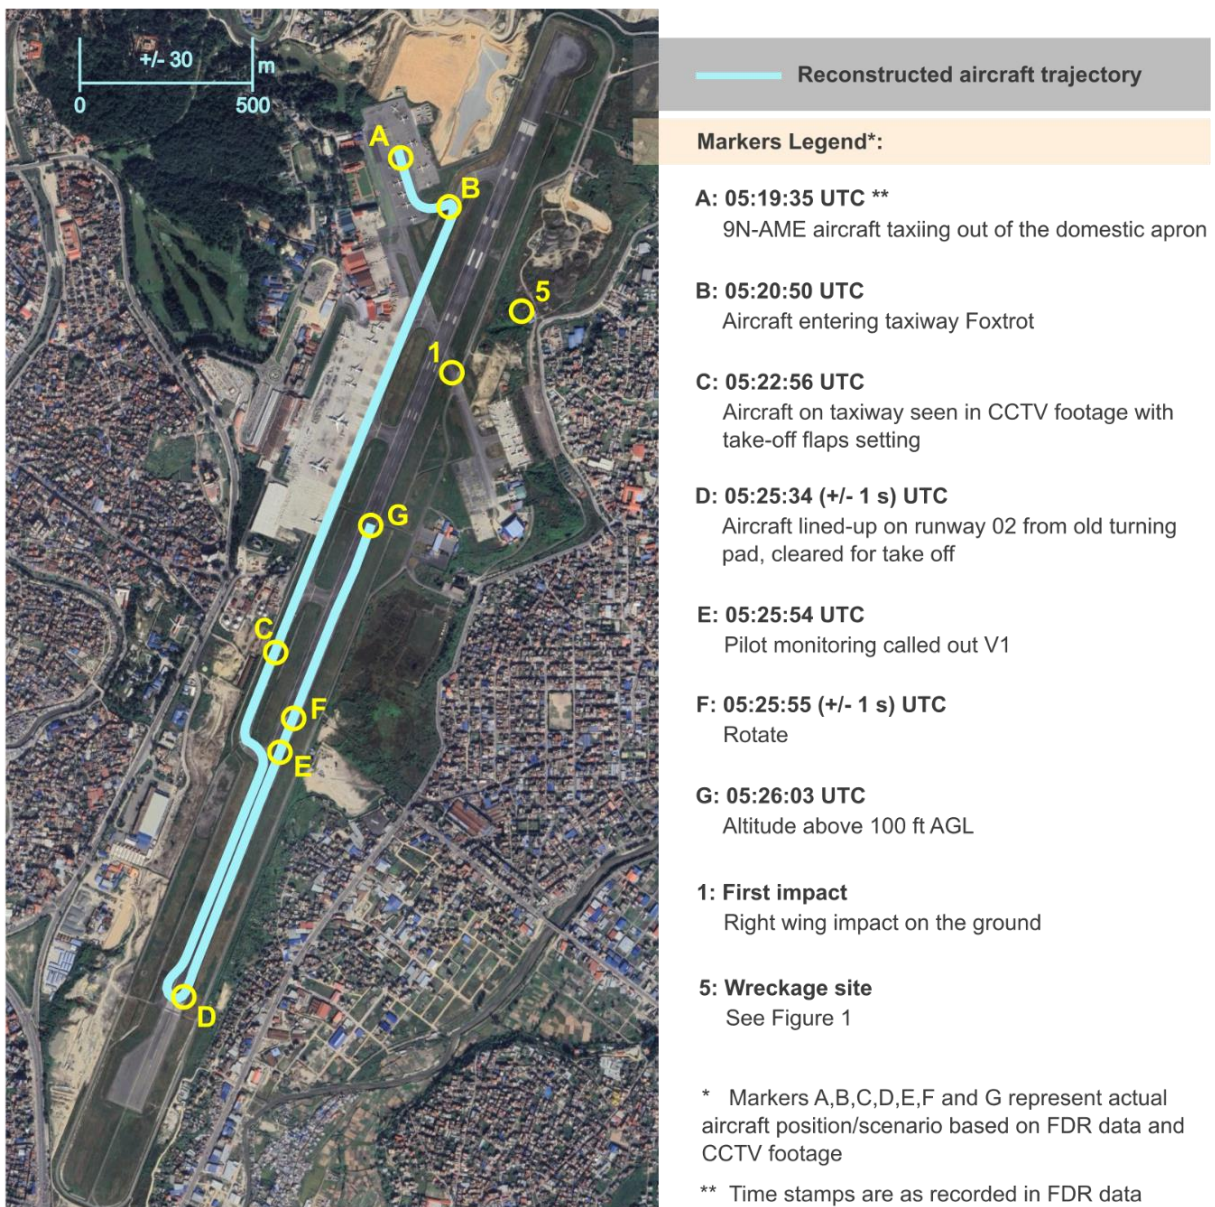
Figure 5: Flight path and event markers

The analysis of FDR data was performed in combination with the investigation of CCTV footages and CVR records. The reconstructed path of the aircraft is shown in Figure 5. The figure includes

the marking on the flight path significant to the comparative observation of the aircraft based on FDR data, CCTV footages, significant CVR audio information, and terrain references. Figure 6 shows the markings C and F as seen in the CCTV footage, while Figure 7 shows the unusual attitudes of the aircraft after take-off leading to the accident. The aircraft underwent a right, left and right bank before the right wing impacted on the ground at '1'.

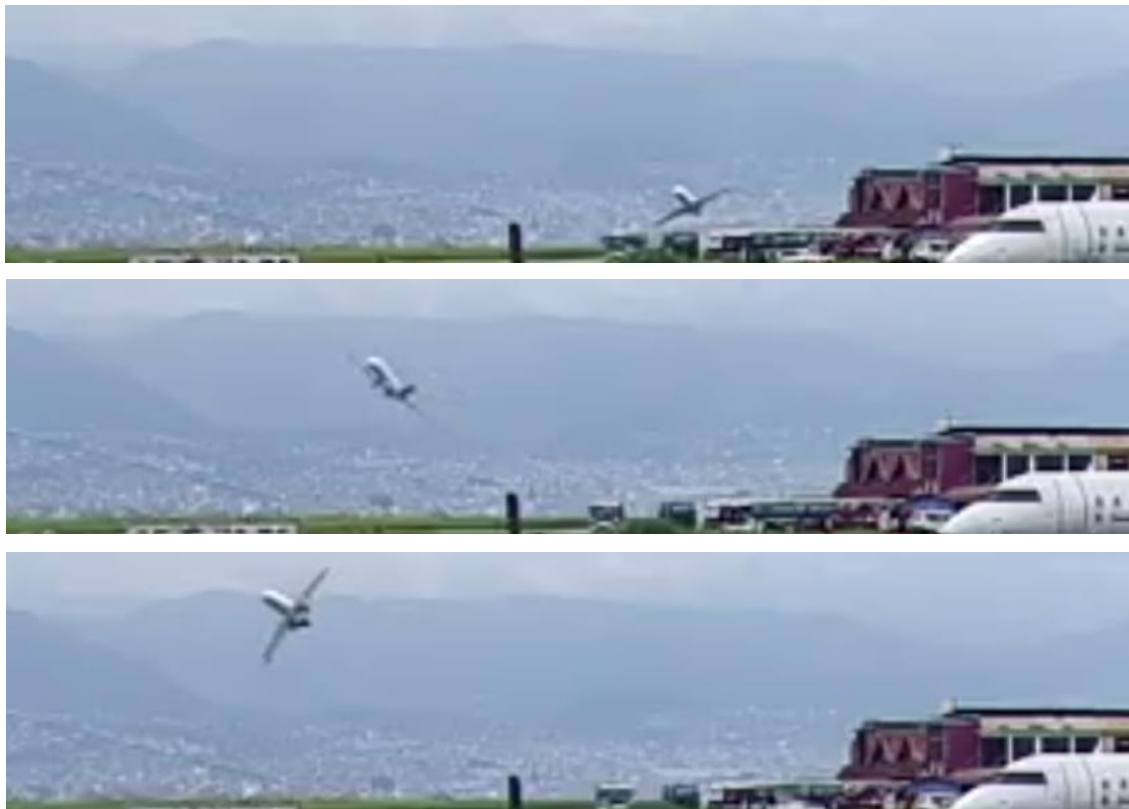
Figure 7: Event sequence with unusual attitudes leading to the accident, captured by a CCTV camera. Almost immediately after rotation, the aircraft first went into a right wing down attitude, followed by left wing down-right wing down sequence. This sequence can be discerned from Figure 7. In

the duration while the aircraft oscillated about its longitudinal axis, the pilot-in-command (also the pilot flying), provided a series of inputs to the control wheel to correct the aircraft attitude.

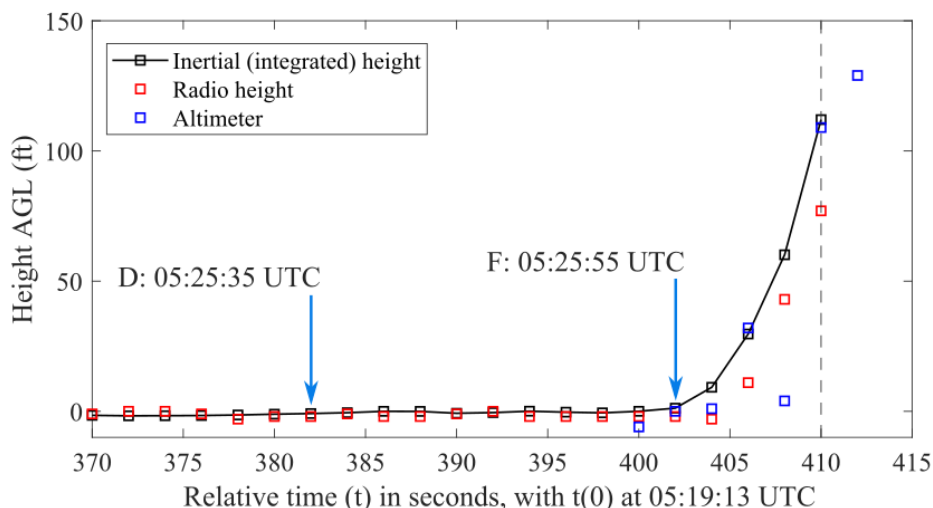
Figure 8: Height of the aircraft during the flight

After rotation for take-off at 05:25:55 UTC, the aircraft attained a height of 50 ft above ground level (AGL) within 5 ± 1 seconds. The height from the radio altimeter and pressure altimeter is shown in Figure 8, which indicates that the aircraft attained a height of slightly above 100 ft AGL by 05:26:03 UTC (marked 'G' in Figure 5, and at $t = 410$ s in Figure 8). At 'G', the aircraft was at 94.6° roll angle with a heading of 24.7° , veering right of Runway 02.

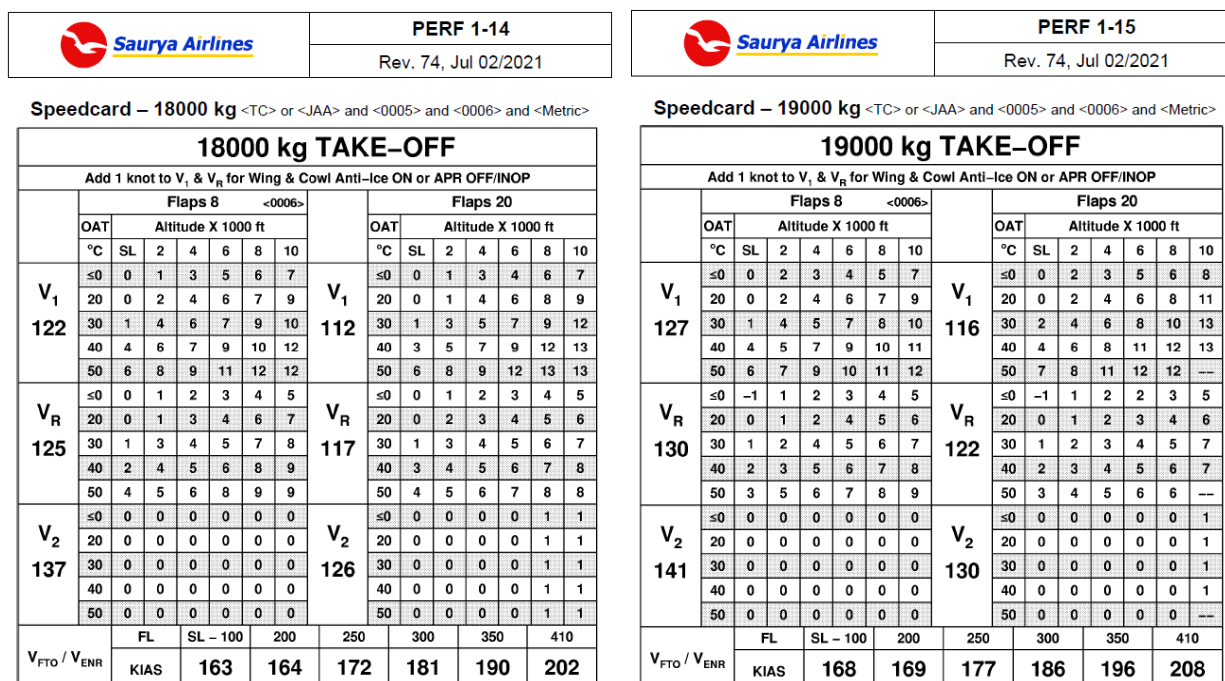
Figure 9: V-speeds references from QRH Vol 1, where the OAT and altitude corrections are also mentioned

- The V-speeds mentioned in the operation flight plan of the event flight, as well as recorded in the FDR, were inconsistent with the Quick Reference Handbook (QRH). Figure 9 shows the relevant QRH values. Also, the interpolated speedcard of the operator for 18500 kg TOW mentions incorrect V-speeds for take-off.
- The procedure followed to issue the flight permission for ‘ferry’ flight (SAU-FER) was not adequate, as the obtained records did not show completeness and compliance with the Procedure Manual for Flight Permission of the Civil Aviation Authority of Nepal, August 2015.

1. All operators shall immediately review their speedcards and RTOW charts.
2. All operators shall comply with the requirements of the cargo and baggage handling. Baggage and cargo weighing, its distribution and latching should be ensured as stipulated in the operation manual and ground handling manual.
3. Civil Aviation Authority of Nepal shall review and update the procedure and requirements for the permission of non-scheduled flights including all non-revenue and ferry flights.
